Shaky Shores

*Coastal impacts & responses to
the 2016 Kaikōura earthquakes*

Special Publication 3, 2018

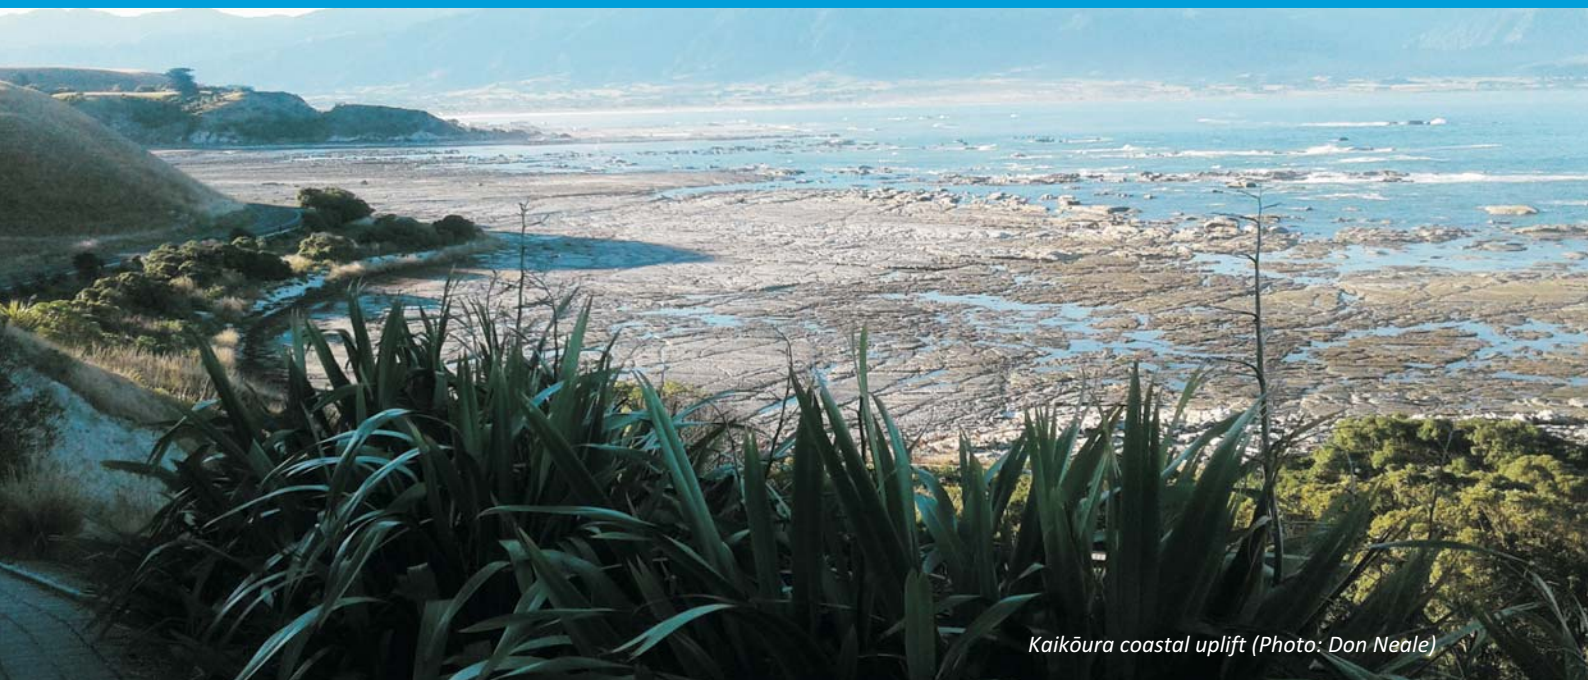
Kaikōura coastal uplift (Photo: Don Neale)

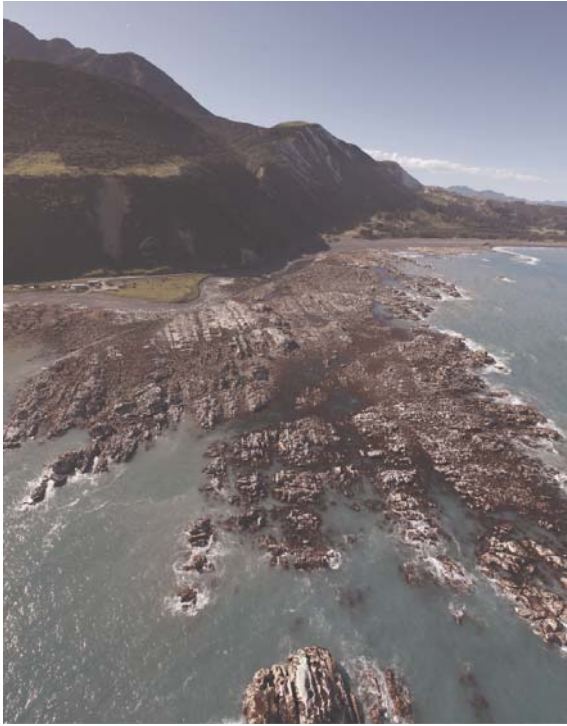
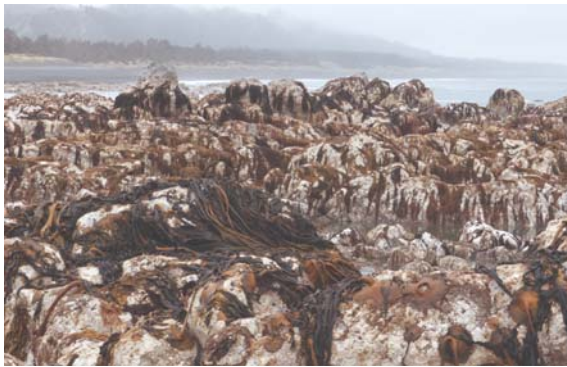
Figure 2: Photos of coastline uplifted in the 2016 Kaikōura earthquake. Top photo shows the point at the north end of Waipapa Bay where the Papatea fault rupture caused 5-6 m of coastal uplift (Photo: Steve Lawson). Middle photo shows detail of the uplifted platform by the Papatea fault (Photo: Ursula Cochran). Bottom photo is from Long Point (10 km southwest of Cape Campbell) where 1.3 m of uplift occurred (Photo: Kate Clark).

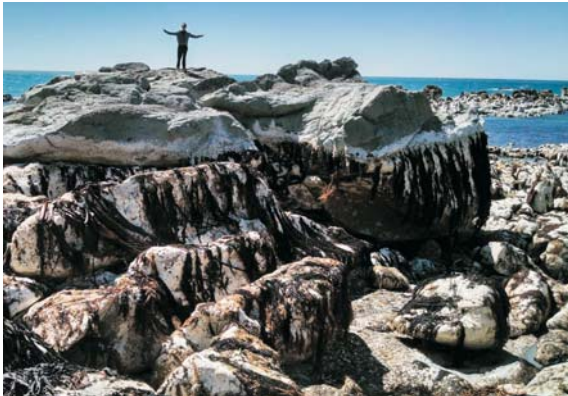
Figure 1: Uplifted reef north of Kaikōura near Waipapa. The vertical algae hanging from the rock on the left is bull-kelp (*Durvillaea poha*), which normally occurs at the intertidal-subtidal margin. Plants are about 2 m long. Below them are newly exposed smaller boulders. The dark algae are furoids which can reach up to about a metre long. The white on the rocks is mostly bleached calcareous algae, which generally forms a primary cover on rocks and boulders from the low intertidal zone downwards. Photo was taken about a month after the earthquake (Photo: D Schiel).

Witnessing intertidal and subtidal habitats, with all of their organisms suddenly exposed, remains one of the most astounding things any of us ecologists have seen. We were able to walk through what were formally subtidal habitats in many areas and see the full array of physical habitats and species that were present. There was massive mortality of seaweeds along virtually the entire coastline. The large habitat-forming algae, with plants up to several metres long, including bull kelp and other strap-like furoid algae were festooned over rocks and quickly drying in the sun.

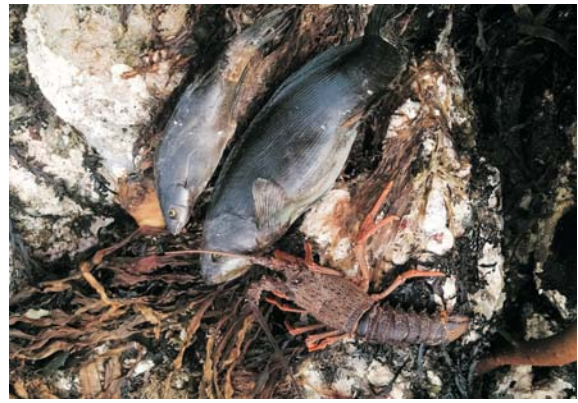
Figure 2: The uplift occurred just after midnight on an incoming tide, when mobile marine animals like lobster and butterfish were actively feeding around submerged reefs. In some areas the speed and suddenness of the uplift was evident in the large number of these animals that were found stranded. Some areas of high uplift, such as Waipapa Bay (pictured), had hundreds of lobsters and fish left permanently above the waterline. Slower moving and sessile animals such as pāua, kina, and mussels had even less chance of escaping back to water (Photo: Marine Ecology Research Group).

newly exposed reefs. Coastal fishes were dead and scattered throughout the uplifted areas, particularly at the more severely affected sites around Waipapa to the north of Kaikōura. These included butterfish (*Odax pullus*) and coastal labrids (*Notolabrus fucicola* and *N. celidotus*). At Waipapa, thousands of lobsters, mostly juveniles, were dead, as were the many species of rocky reef snails, such as the turbinid gastropods (e.g., cat's eye snail *Lunella smaragdus* and Cook's turban *Cookia sulcata*).

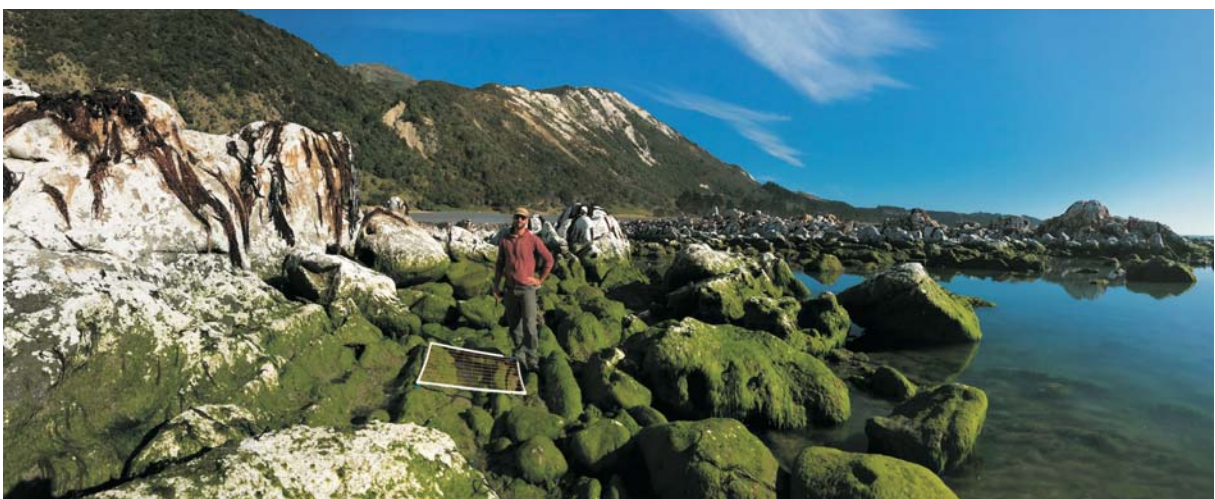
Figure 3: Sea of green. Fast settling and generally ephemeral green seaweeds, often called sea-lettuce, settled throughout the middle and lower intertidal zone beginning about three months after the earthquake and lasting till around December 2017. Their longevity was aided by the massive loss and general absence of grazing invertebrates on reefs along much of the earthquake coast (Photo: D Schiel).

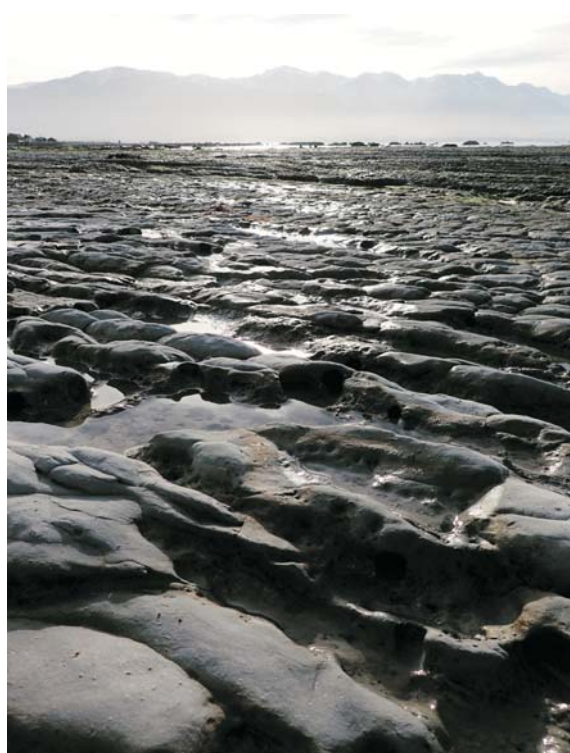
Figure 4: Before (left) and after (right) the earthquake comparison of the rocky reef at Kaikōura that has been studied for over 25 years. This had been one of the highest diversity reefs in New Zealand until the earthquake. It is now devoid of macroalgae except at its lowest margins (Photos: S Gerrity).

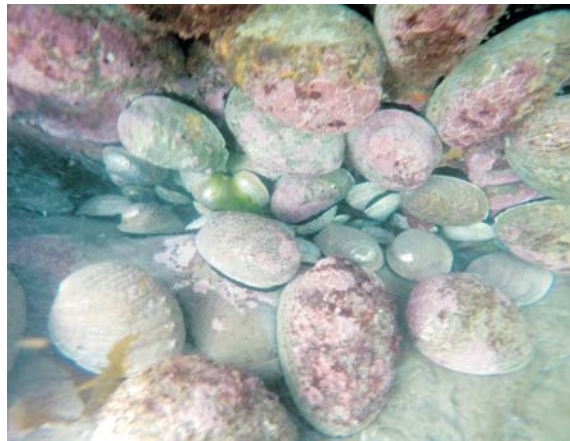
An aggregation of adult (130 mm+) and juvenile (<80 mm) pāua. It is unusual to see juvenile pāua exposed in habitat like this. We suspect that they may have been forced to leave their normal habit under boulders (cryptic habitat) due to influx of fine sediments resulting from slips and other earthquake effects (Photo: Tom McCowan).

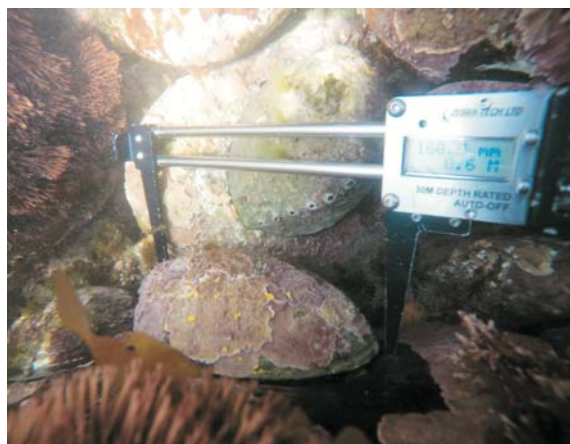
Measuring pāua during biomass estimates using underwater electronic callipers. Pāua that have been measured are marked with a yellow crayon so they are not re-counted during that survey (Photo: Tom McCowan).

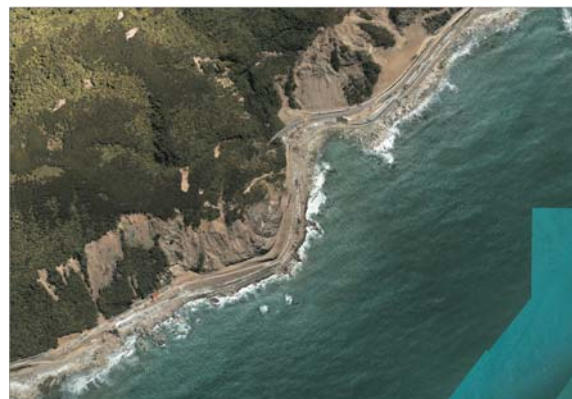
SH1 at Ōhau Point in December 2016 (top) and in November 2017 (bottom) (Photos: NCTIR).

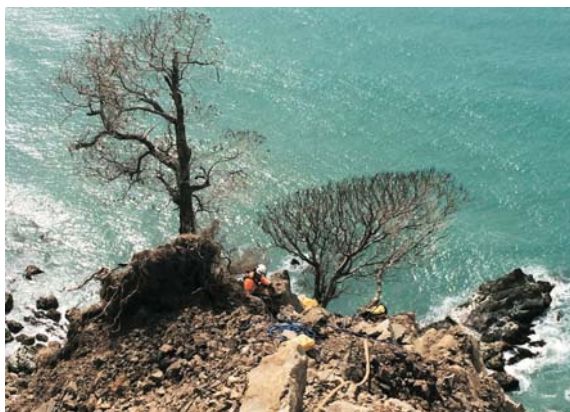
Abseilers clearing loose rocks to stabilise the cliff face (Photo: NTCIR).

high bluff was in places too narrow for horses to pass. Securing that landslide with mesh and rockfall protection was critical to the re-opening of SH1. Abseilers using drill rigs suspended by ropes bolted the hilltop to keep it from moving. Once those anchors were in place, helicopters hung sheets of mesh, which were then fastened into place by hand.

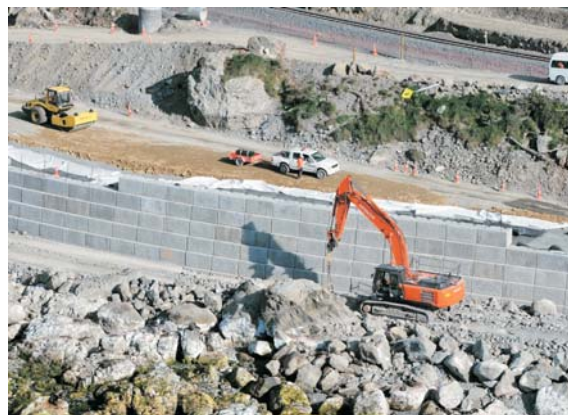
Seawall construction work underway near Ōhau Point (Photo: NTCIR).

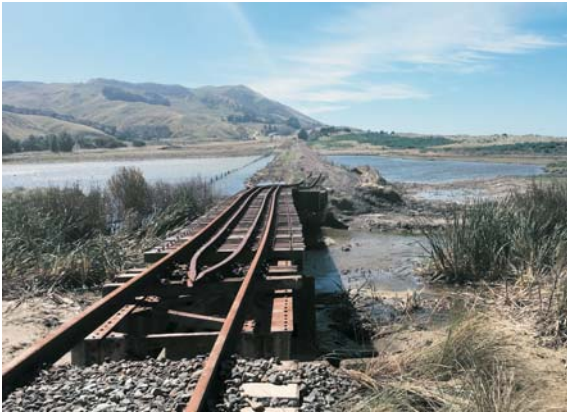
Rail Bridge 129 at Tirohanga post-quake (Photo: NTCIR).

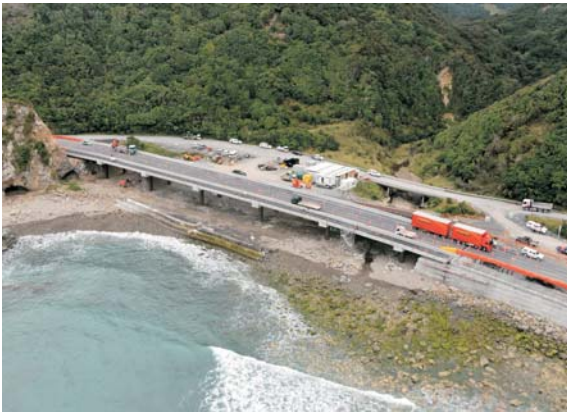
Work on the new, seven-span Irongate Bridge, north of Mangamaunu, nearing completion (Photo: NTCIR).

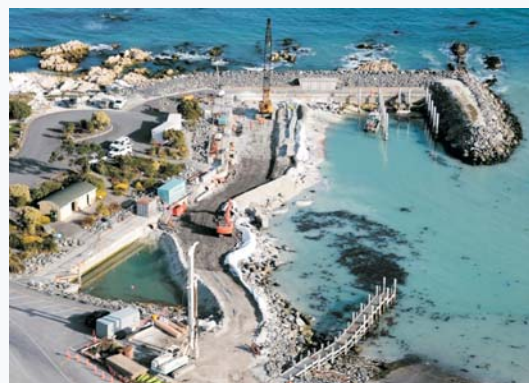
Work underway on repairing Kaikōura Harbour (Photo: NTCIR).

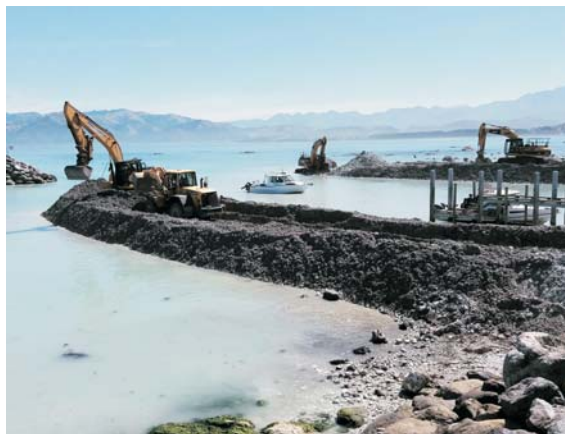
Kaikoura marina being dredged out to make it usable again (Photo: Hamish Rennie).

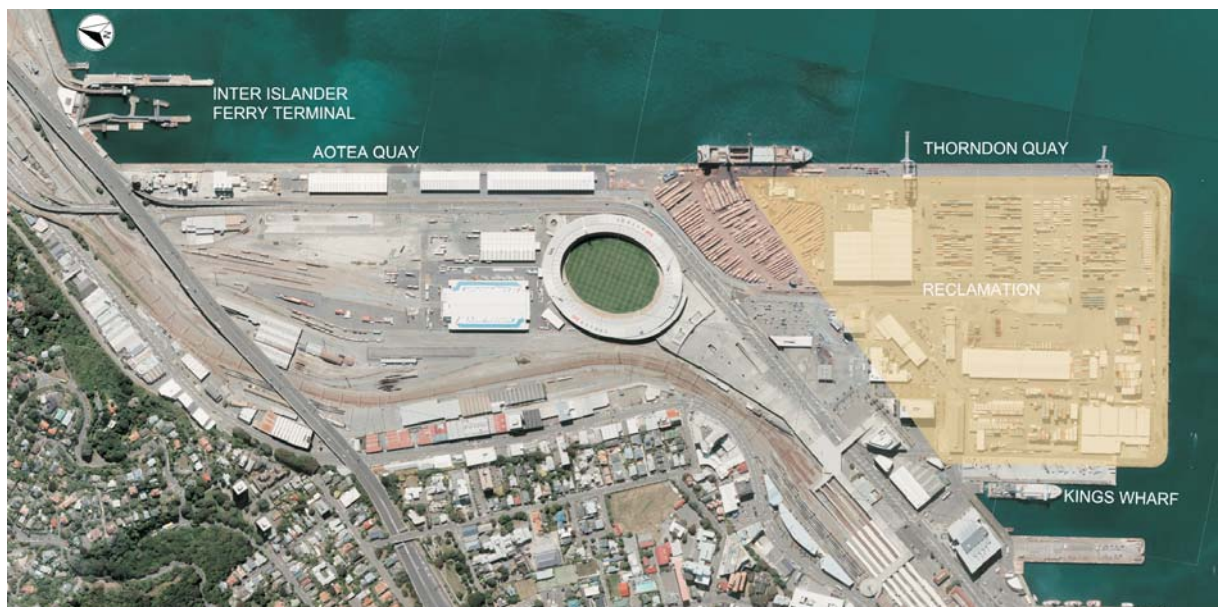
Figure 1: CentrePort asset locations (Graphic: CentrePort).

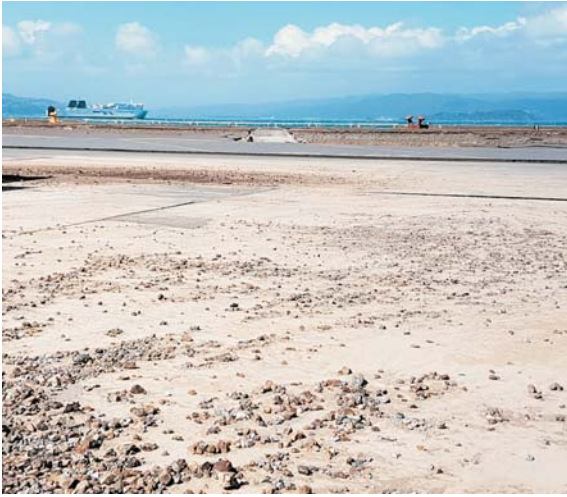
Liquefaction within the container terminal (Photo: CentrePort).

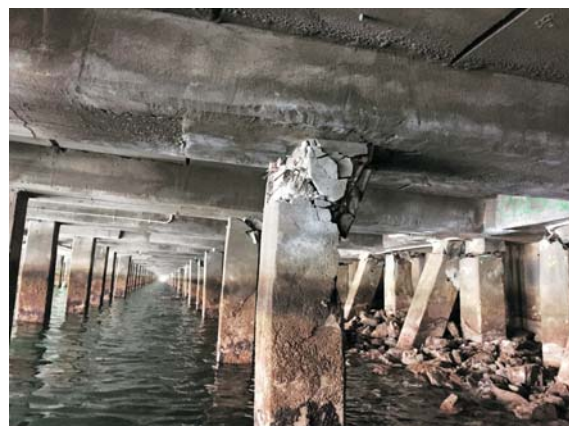
Pile damage under Thorndon Container Wharf (Photo: CentrePort).
