Dispatches from the firing line...

February's Cyclone Gabrielle was both a significant and widely reported event. Much of the media response focused on the inland impacts; in this issue we look specifically at the coastal impacts, including a comprehensive regional roundup, beginning on page 3.

From 12-14 February, Cyclone Gabrielle passed the northern and eastern regions of the North Island, exposing much of the island to extreme rainfall and river flooding not seen in many years, catastrophic wind damage, and substantial storm surge.

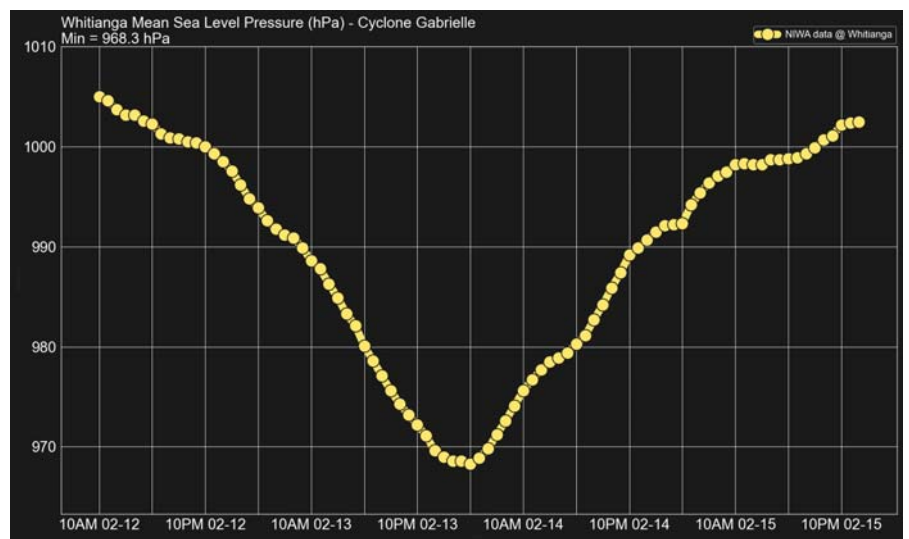
Figure 1: Mean sea level pressure readings at Whitianga from 12-15 February; the centre of Gabrielle made its closest approach in the early morning hours of 14 February, seeing the pressure dip to 968 hPa.

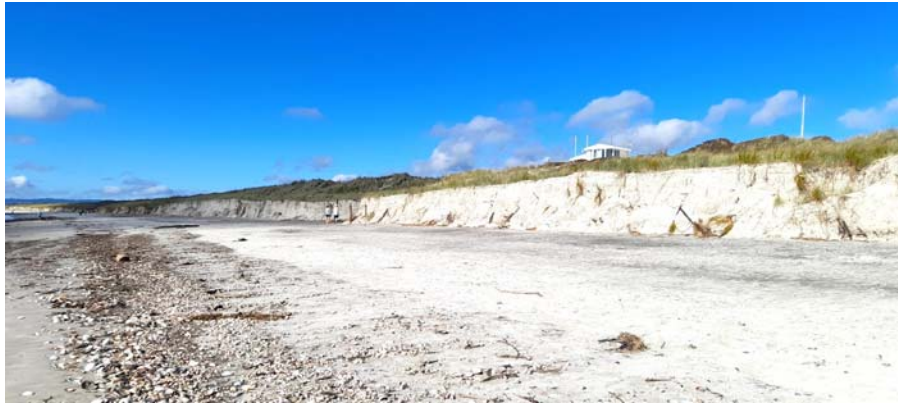
Erosion in front of Ruakākā surf club. Intensive weed control in this area means that there is a good buffer of spinifex dune which, given the right conditions, will self-recover over time (Photo: Northland Regional Council).

Dune toe retreat levels varied considerably around Bream Bay, with Bream Tail providing protection to the more southern sites and the areas in the middle of the bay experiencing most erosion. At Waipū Cove the dune toe retreat varied between 2 m and 5 m. By contrast, the retreat in the area near Ruakākā surf club was up to 12.5 m and up to 17 m at Uretiti. However, at both sites there is a relatively wide, healthy dune and sufficient remaining width. The remaining width of dune and the presence of suitable dune plants will enable the dune to naturally

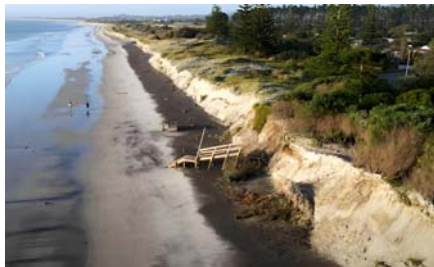
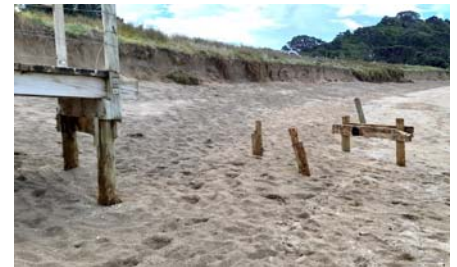
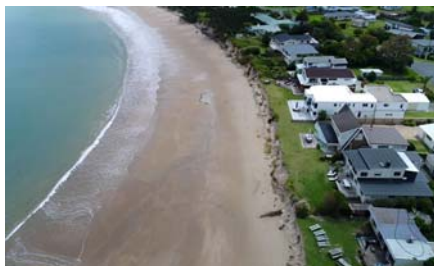
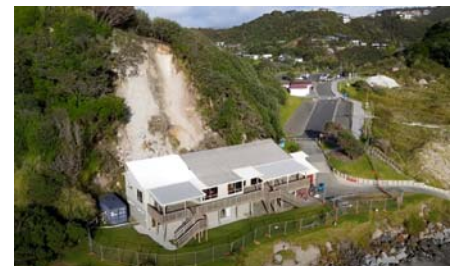
Top left: Erosion of dune at Marsden Point leaving these access steps at separated from the land. These have now been removed; Top right: Damaged accessway at Matapouri, February 2023; Bottom left: Whangaumu (Wellington) Bay, near Tutukaka, February 2023, showing storm erosion and damage to private access structures; Bottom right: Large slip behind Mangawhai surf club (Photos: Northland Regional Council).

Hard structures, such as access steps and boat ramps were badly impacted at many east coast beaches. In some areas these have been reinstated by district councils, with some modifications. At other sites more flexible options are being considered. Coastal businesses in Paihia and Waitangi suffered damage by either storm surge or by the physical impact of waves battering decks and wharfs. The Mangawhai Heads Surf Lifesaving club building was damaged by a slip on the maunga behind. Many Urupā and other sites of cultural significance around Northland are also at risk from coastal erosion.

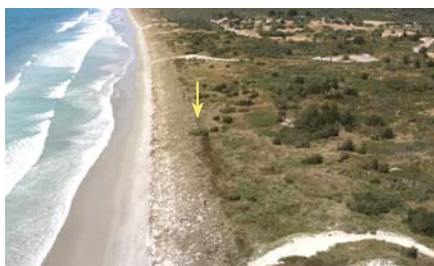
Left: Drone image of Uretiti taken in the summer of 2021. Take note of the tree under the yellow arrow; Right: Drone image of Uretiti taken in March of 2023 after Cyclone Gabrielle. The tree under the yellow arrow demonstrates the extent of erosion (Photos: Northland Regional Council).

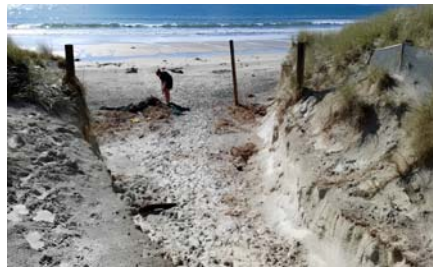
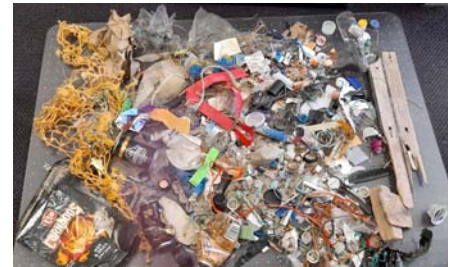
Left: NRC staff picking rubbish out of a pile of storm deposited debris at the Ruakākā surf club ramp; Right: Some of the litter collected during Seaweed by Bream Bay Coastal Care Trust (Photos: Northland Regional Council).

Cyclone Gabrielle not only caused erosion on our coastlines, but significantly increased litter entering the coastal environment. Many groups and individuals regularly pick up litter from our beaches and have had to increase this since the storm events. Some of the litter was from fences and accessways and this has been a reminder to consider what materials are used and, where possible, remove temporary fences before storm events.

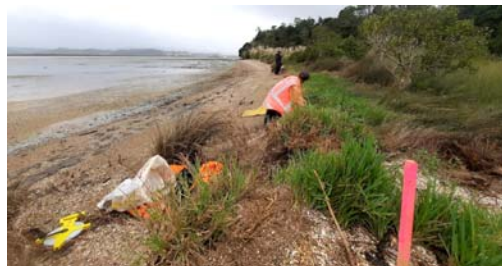
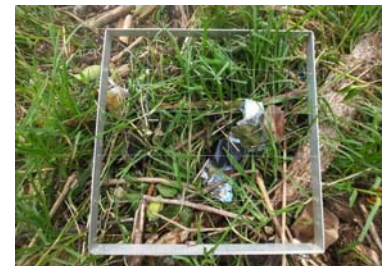
Left: Post-cyclone litter Intelligence survey, Onerahi, May 2023; Right: One of the quadrats used in the survey (Photos: Northland Regional Council).

visually and had dropped from a Visual Assessment Grade A to C. Estimated litter density was 22,667 items per 1,000 m², in comparison to 203 items per 1,000 m² counted during the survey on 7 February 2023.

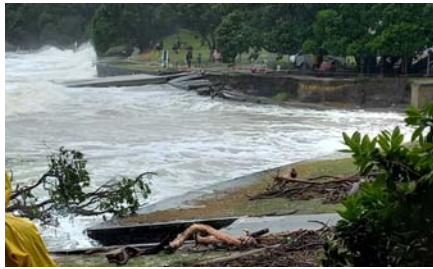
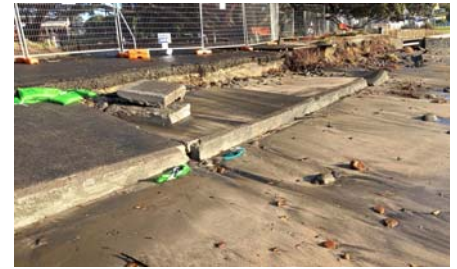
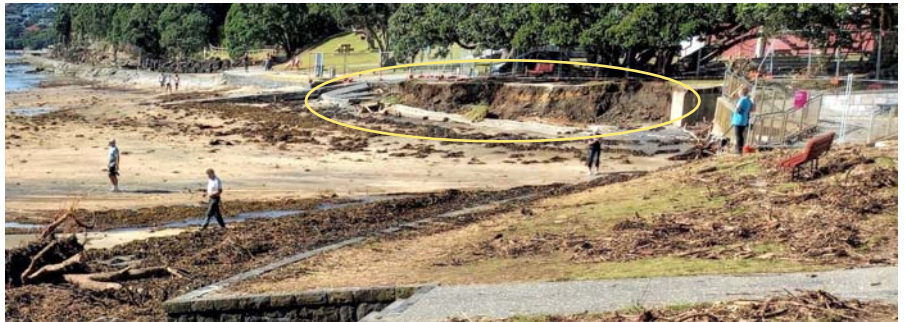
Murrays Bay, East Coast Bays: Failed section of seawall during and post the Cyclone Gabrielle storm (Photos: Auckland Council).

A section of the Murrays Bay seawall adjacent the bays stream mouth was undermined and failed during the 27 January Auckland flooding event.

This triggered the renewal of a 48 m length of failed seawall. The opportunity has been taken to implement an improved and more robust seawall design. The replacement structure is to be more visually consistent with immediately adjacent seawalls, and will provide for improved foreshore access.

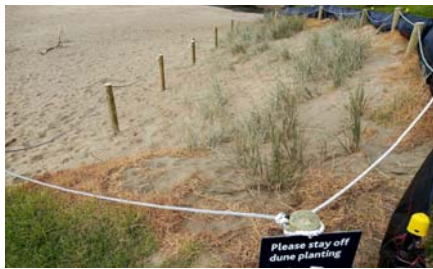
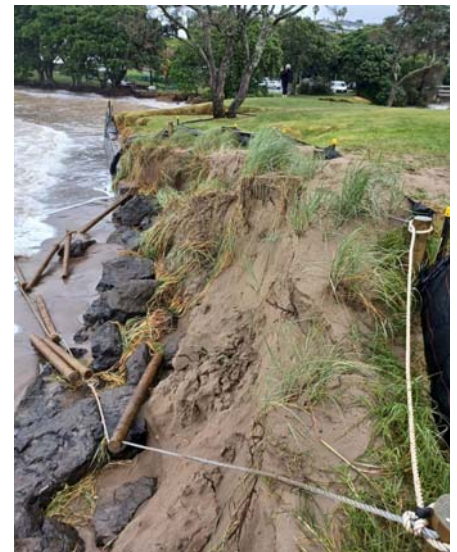
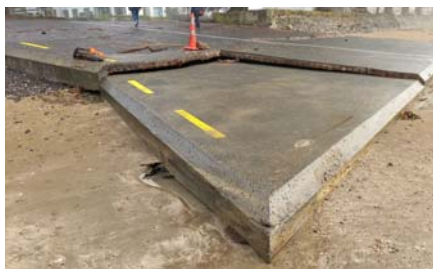
Browns Bay, East Coast Bays: (Top left and right) Dune planting pre- and post-storm event; (Bottom left) The damaged Browns Bay boat ramp, and lowered sand levels (Photos: Auckland Council).

Browns Bay is typically a relatively low energy beach, sheltered by an offshore reef. However, elevated water levels during the Cyclone Gabrielle event significantly increased the wave energies that the beach was exposed to. This resulted in significant lowering of the upper beach, eroded dune planting, exposed backstop rock armouring and wastewater infrastructure, and damaged the Browns Bay boat ramp.

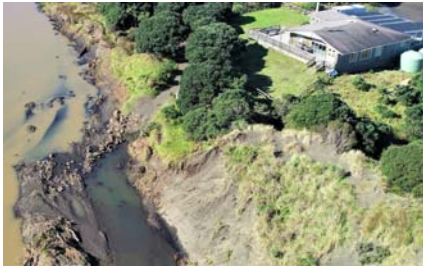
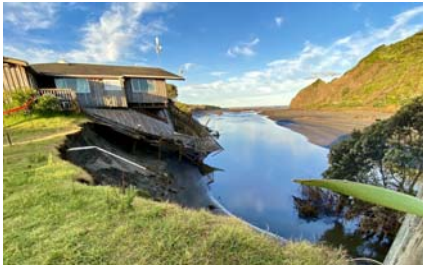
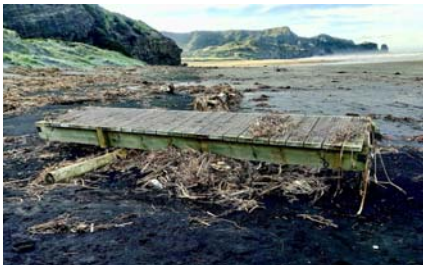
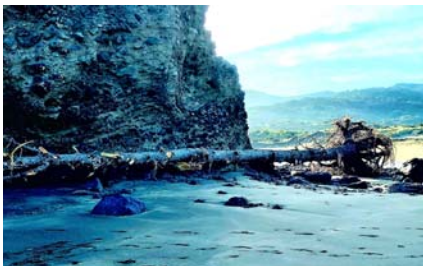
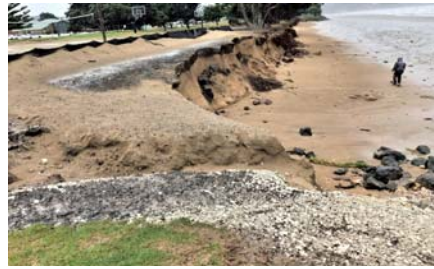
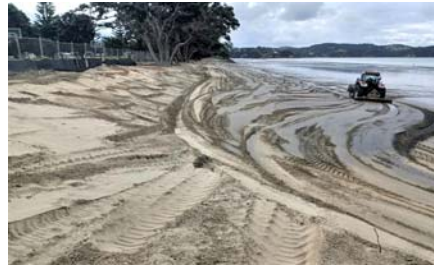
▲ *Orewa Beach, Hibiscus Coast: (Top left and right) Post storm event erosion; (Bottom left and right) Post sand transfer works (Photos: Auckland Council).*

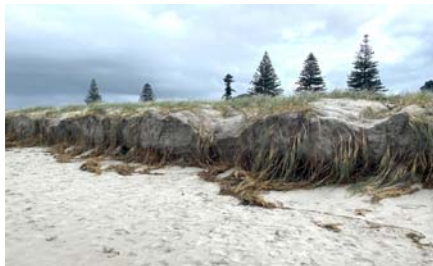
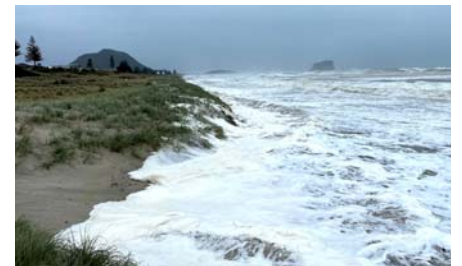
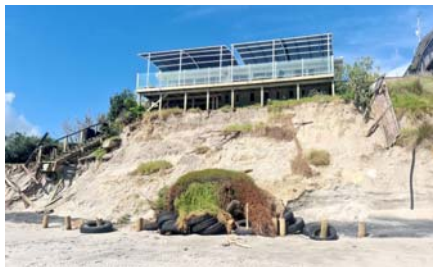
Cyclone Gabrielle erosion at Mount Maunganui (top left and right) and Pukehina (bottom) (Photos: Alison Clarke).

However, the coastal environment was not left unaffected by Cyclone Gabrielle. A maximum significant wave height (H_s) recorded at BOPRC’s Pukehina wave buoy was 5.8 m. These large swells damaged a number of beach access structures and

caused widespread erosion of the region’s sand dunes. Dune scarps up to 2 m were reported across large sections of the Tauranga Coastline.

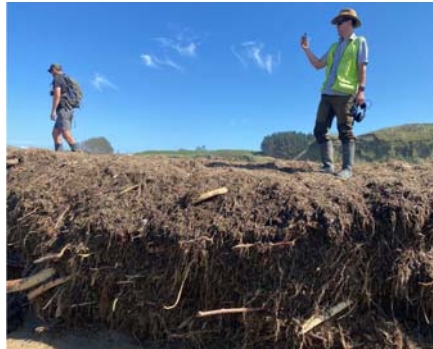
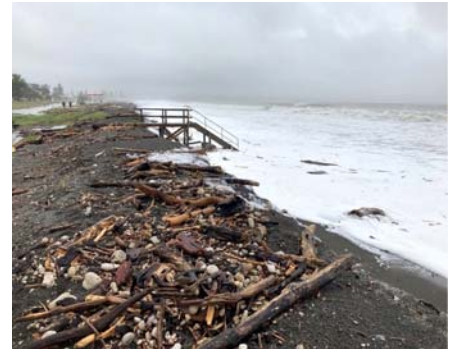
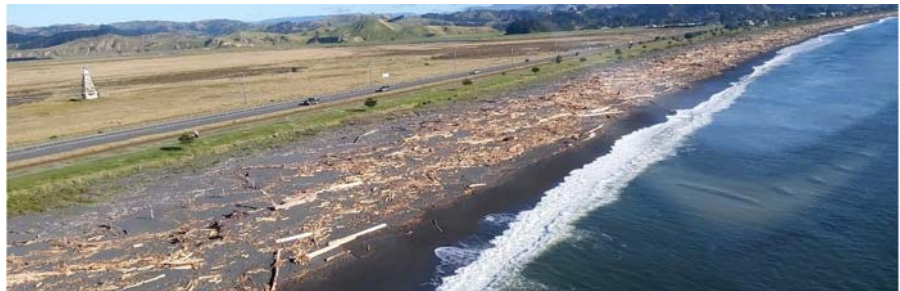
Accumulation of woody debris at Waikare beach (top left, Photo: Dan Fake, HBRC) and at Westshore 14/2/2023 (top right, Photo: Pippa McKelvie-Sebileau); Beach debris south of Bay View (bottom, Photo: HBRC, from Coastal Sweep pictures taken 23/2/2023).

Large amounts of woody debris were found at beaches, river berms, bridge abutments and piers, and floodplains. At some beaches, the accumulation of debris was higher than 2 m over the beach, as shown in the photos (below). Large rafts of floating woody debris in the sea were observed in aerial surveys after the cyclone.

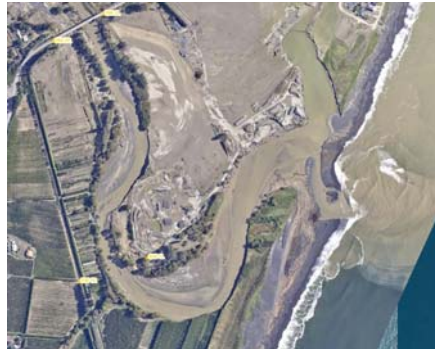
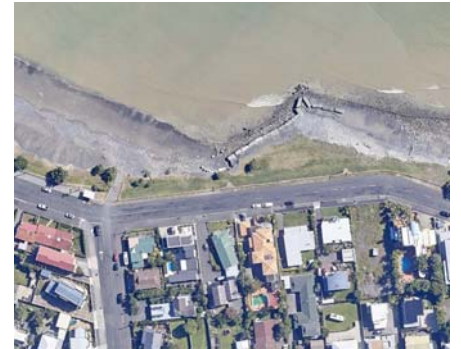
Significant erosion at the Esk rivermouth (left, Photo: HBRC), and erosion at Westshore (right, Photo: HBRC, Post Cyclone Aerial Imagery).
